Blue Mountains Conservation Society Inc

25 July 2017

Fairmont Resort, 1 Sublime Point Road, Leura, NSW: Report of ongoing pollution incidents involving on-site sewer pumping station

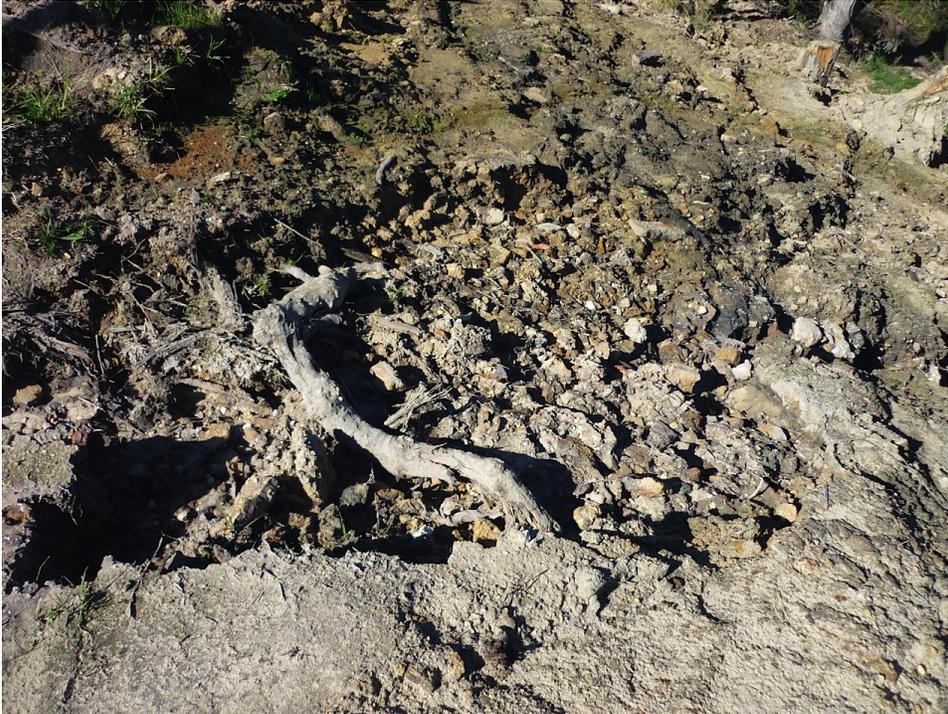
- May 3. Fluid was seen leaking from the concrete pipes at the sewage pumping station downhill into the national park. A very strong and offensive smell of effluent was so prevalent the walking party could not remain in the area.
- May 10. Evidence of major sewer overflow with waste flowing downslope of the pumping station into the national park, resulting in significant erosion gullies.
- May 24 Evidence of staining down the slope consistent with a sewer overflow. Presence of Inkweed located at the bottom of the slope below the sewer pump, which is an indicator of high nutrient levels.

May 10 Top Photo. Clear evidence of sewage overflows including gully erosion. Bottom photo. Inkweed growing below gully erosion

- immediately investigate the above pollution incidents;
- require the Fairmont to take appropriate remedial action, including upgrading the pumping station so it can adequately deal with the amount of sewage from the resort; and
- require that, as part of the upgrade, the pumping station is moved a considerable distance away from the boundary to the Blue Mountains National Park and adequate measures are put in place to ensure that any sewage overflows that occur in the future do not enter the national park.

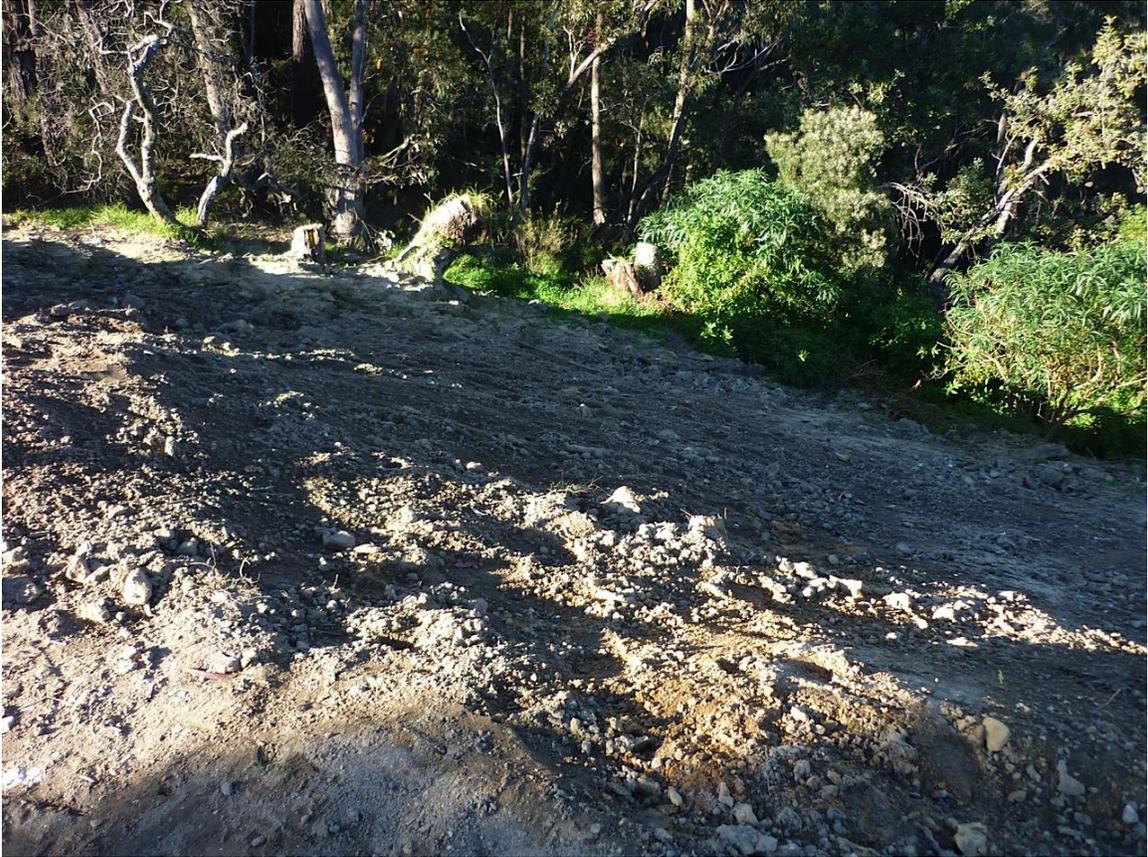
- May 30. Area around pumping station had been cleaned and new soil had been placed in the two largest erosion gullies downhill in the national park.
- July 05. Evidence of another major overflow. The pump area was relatively clean but below the pump area there were remnants of waste and the slope was eroded again.

May 30. Repair of gully erosion, including soil placed down slope

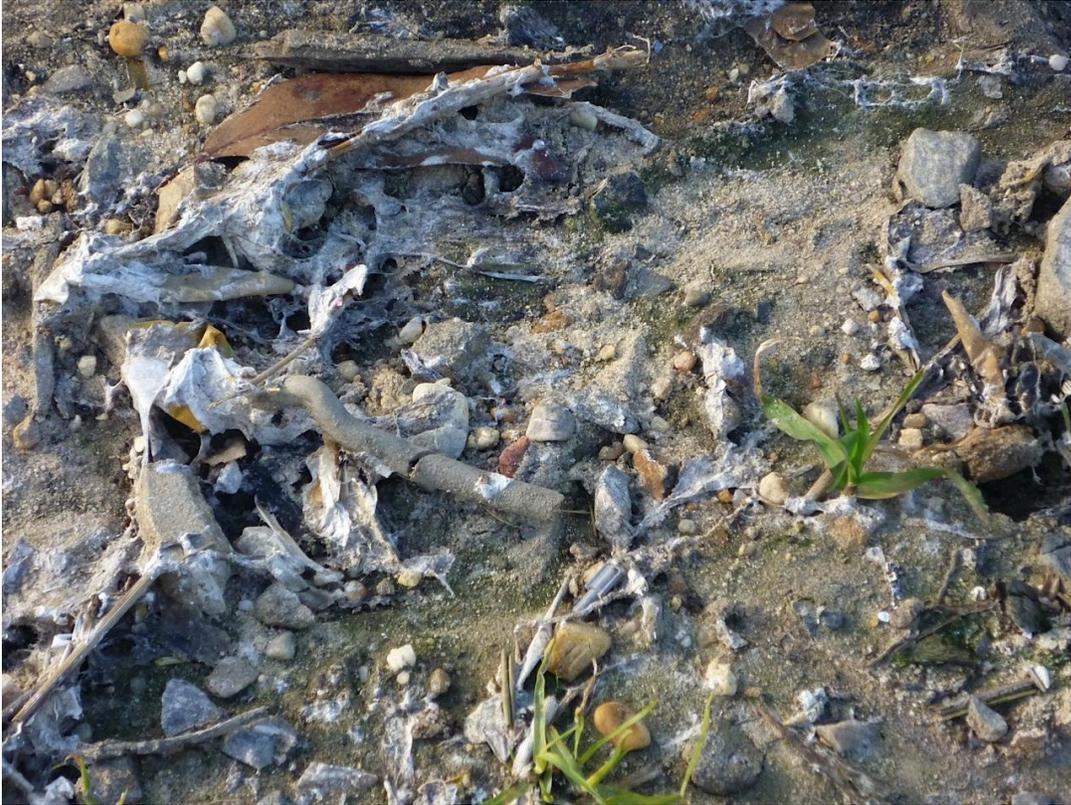
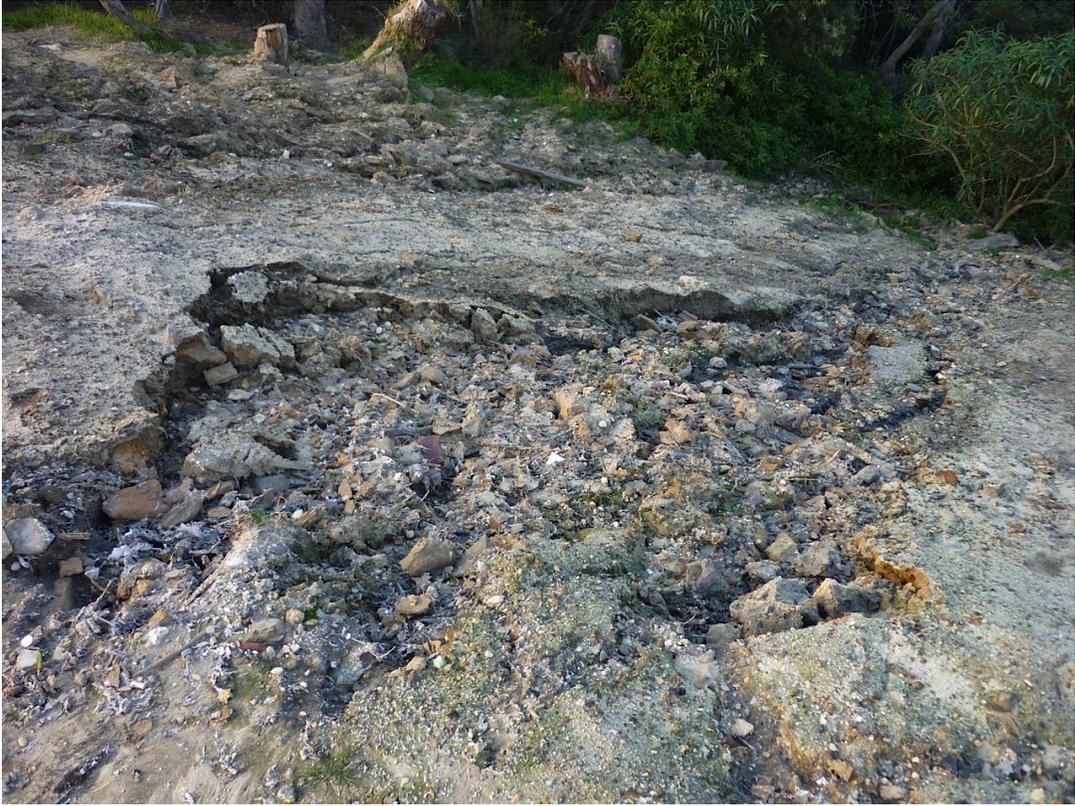
July 5. Clear evidence of sewage overflow. Gully erosion below pumping station as well as sewage refuse on site.
