Former Railway Tunnel, Lapstone – ongoing storage of mushroom compost and associated waste, and resulting possible pollution of nearby waterways and groundwater

However, a recent inspection in July 2017 found the following:

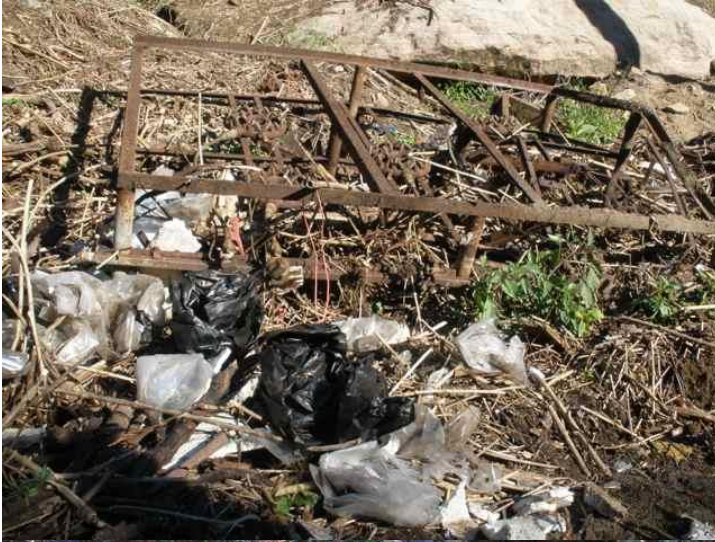
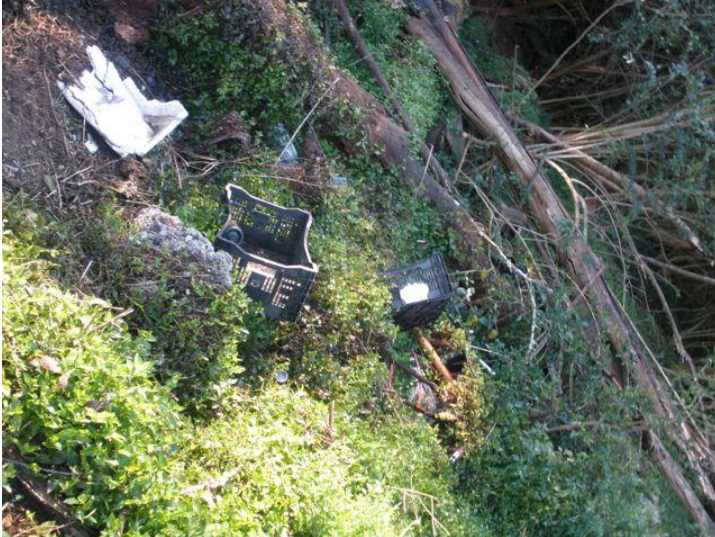
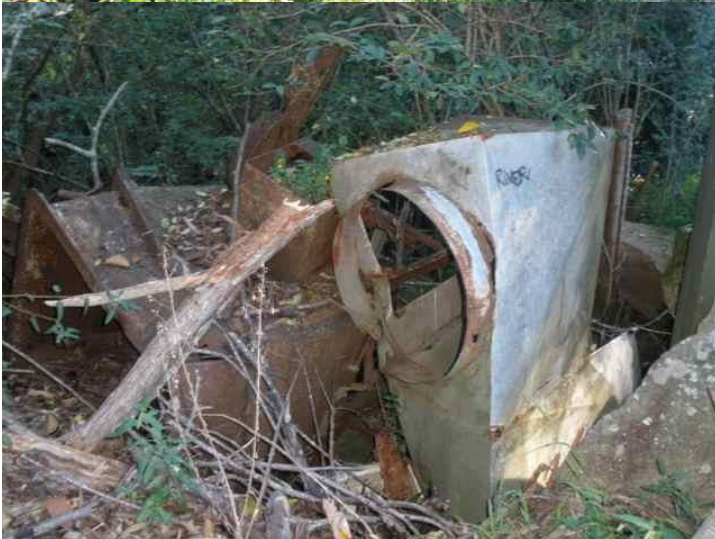
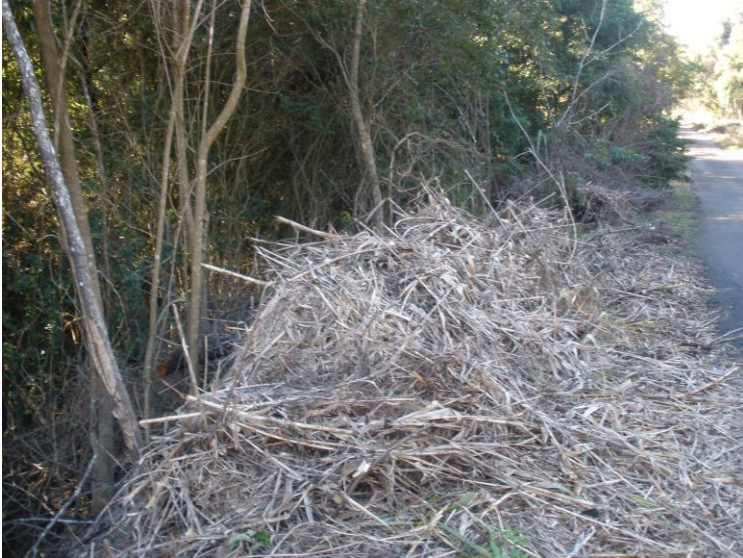
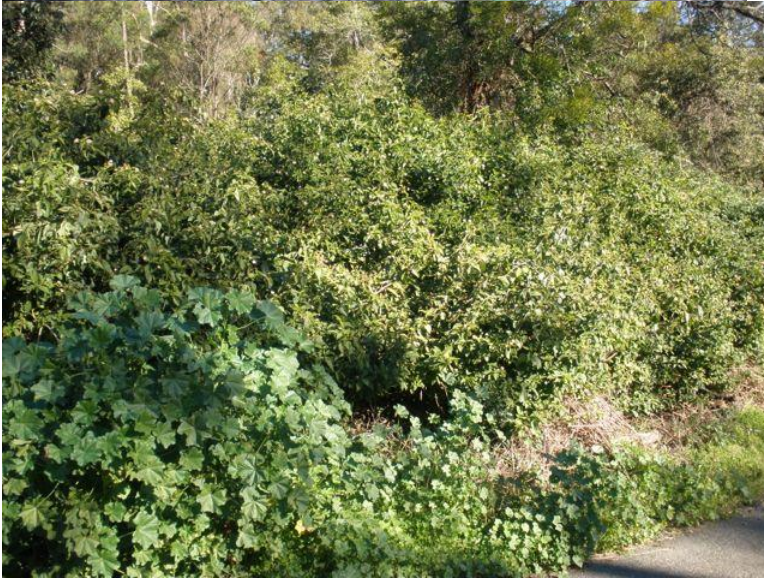
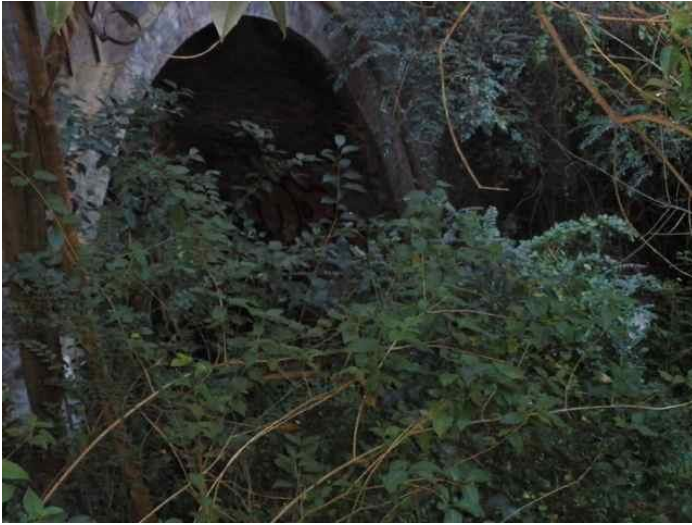
- Old machinery and rubbish still remains on site (see attached photos). This has encouraged further illegal dumping (see attached photos).
- A considerable weed problem remains (see attached photos). Weeds which have been killed remain in situ and have not been removed. Additional weed and bush regeneration is required.

- The soil appears to be contaminated with crushed rubble and small pieces of plastic and metal.

July 2017 Outside the tunnel: photos showing weeds, and rubbish and old machinery still on site

- Issue a clean-up notice under sec 92 of the *Protection of the Environment Operations Act*, requiring the Department of Industries-Land to remove all compost, asbestos and other waste from the tunnel and surrounding areas, and undertake suitable site remediation, including weed removal and bushland regeneration. The clean-up notice should require that the clean-up commences urgently given the high pollution risk and is completed within 12 months. The notice should also require ongoing water quality testing until the site is remediated.

- Require the Department of Industries-Land to immediately undertake soil contamination testing to ensure that the land surrounding the tunnel subject to mushroom composting activities is not contaminated, as well as undertake water quality testing of nearby watercourses, and make the results of the testing publicly available.

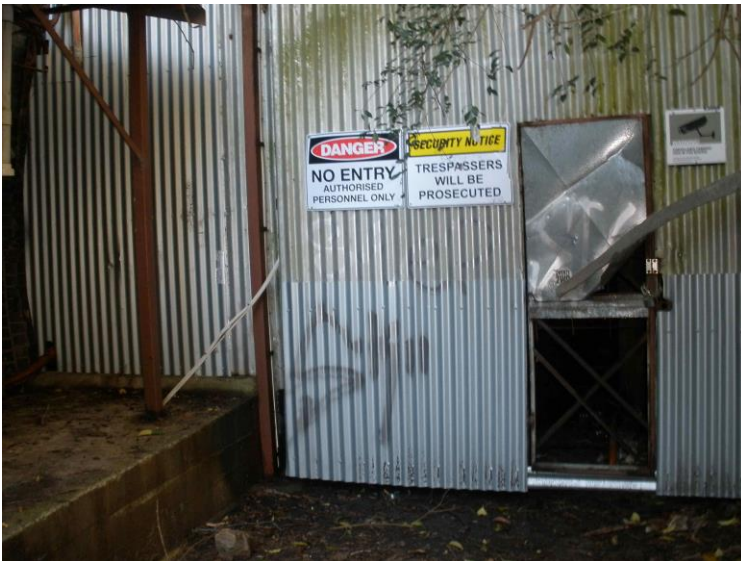
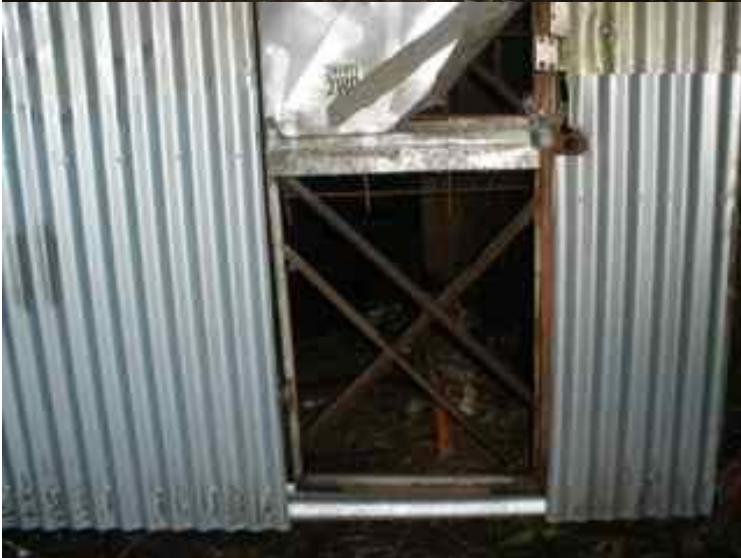
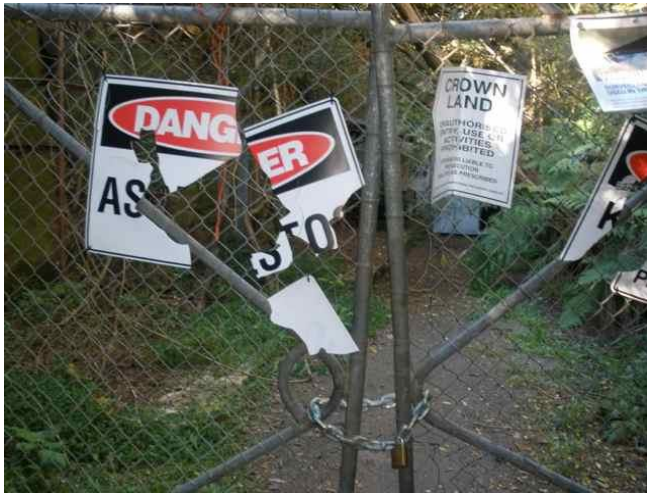
- Illegal access to the tunnel is still occurring (see attached photos), as is continued graffiti of the tunnel and surrounding area. While some security works such as gating, fencing and locks have been installed in the last 12 months, it has not been sufficient to deter illegal access. More durable, robust and effective security measures are required to prevent illegal access into the tunnel, as well as the installation of new health warnings signs and implementation of adequate security measures to deter illegal access, including installation of covert cameras and associated signage.

Given the ongoing lack of durable and effective security being installed at the tunnel entrance, and the continued evidence of illegal entry into the tunnel by members of the public, the tunnel also represents a risk to public health and safety. Asbestos is known to occur in the tunnel and the sludge and compost waste represents an unknown health risk for anyone entering the tunnel. The current health warnings signs are inadequate.

July 2017 Photos showing inadequate health warnings signs and inadequate security measures enabling illegal access to the tunnel

- Require the Department of Industries-Land to install durable, robust and effective security to prevent illegal access into the tunnel, install new health warning signs and implement adequate security measures to deter illegal access including installation of covert cameras and associated signage.

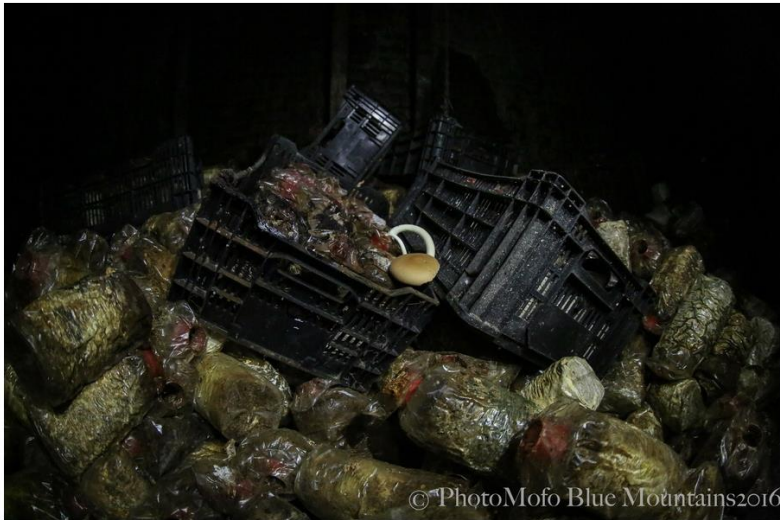
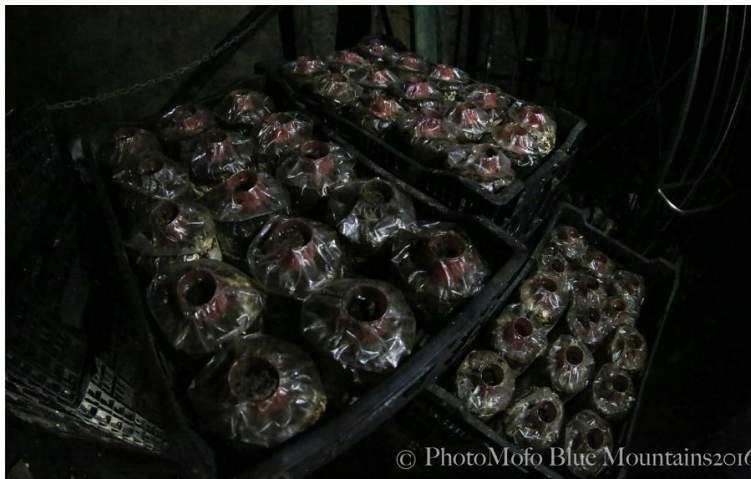
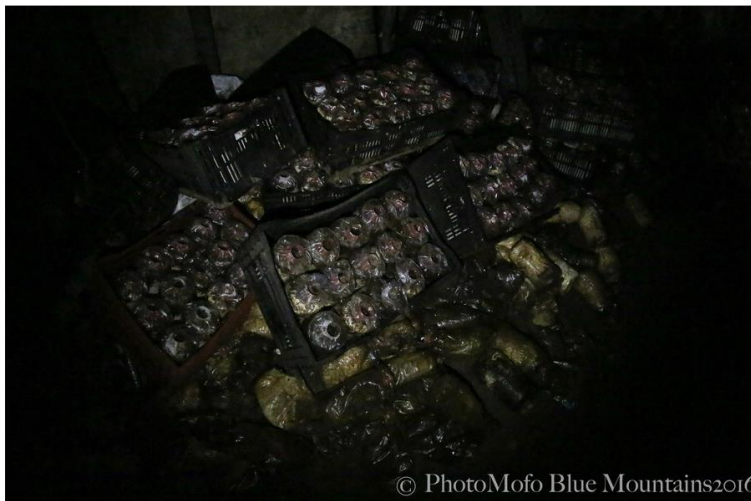
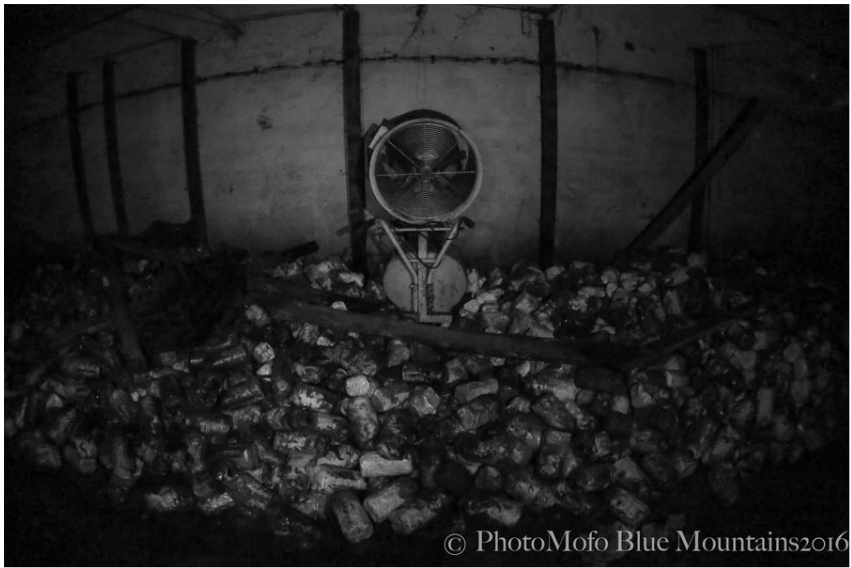
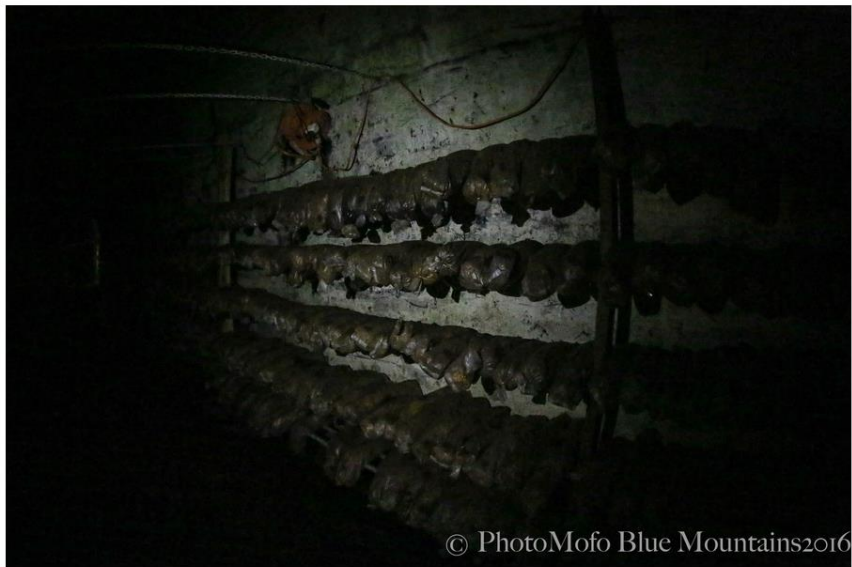
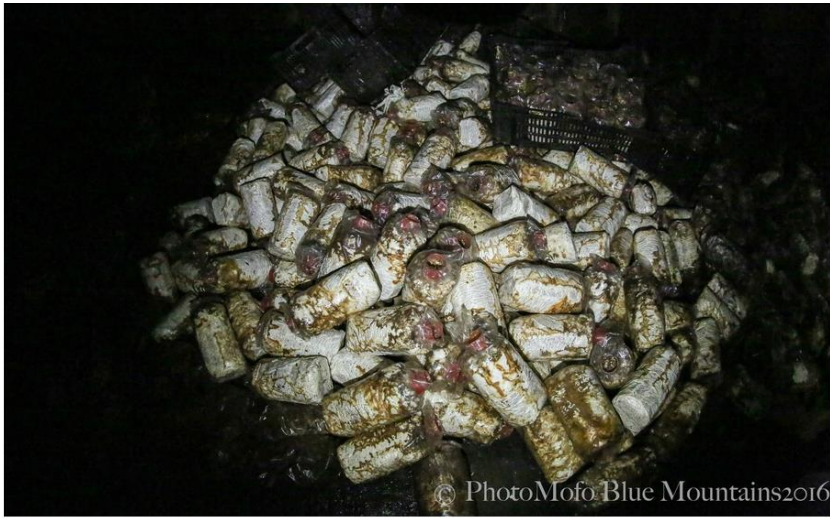
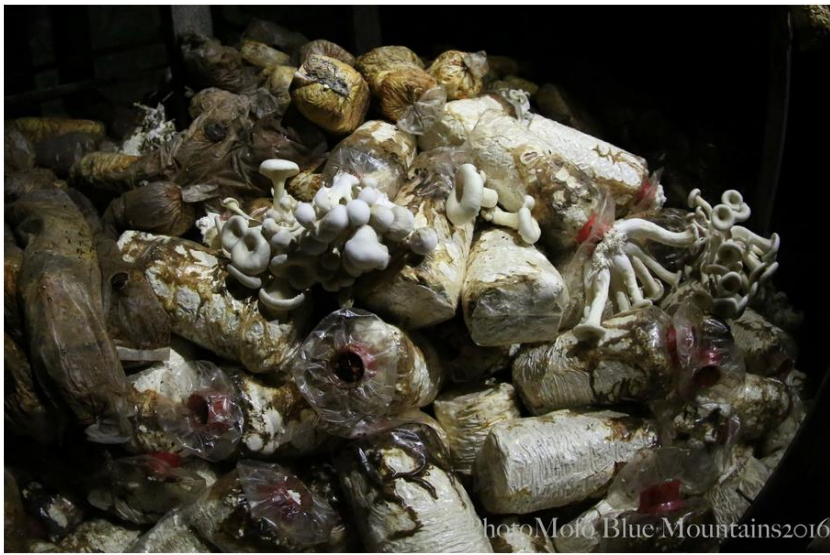
So we set off into the darkness with no idea what we were going to encounter. ... Stacked down the sides to the tunnel there were old fridges, forklifts, trolleys and whole pallets of 2 litre jars. Why jars? There were lots of ladders, wire crates, fans and about 50 column heaters (which in my opinion would have been probably the least economical way to heat a tunnel).

..The concrete floor was covered with water and sludge. It was pitch black and dank and smelled rather musty and organic. The further in we got, the more the humidity rose. It wasn't overly warm in there, just humid and dank.

... Not only were they grown in plastic, they were grown in single use plastic, and it was being dumped in a giant pile at the end of the tunnel. When I say a giant pile, I mean freaking huge pile of approximately 200+ one ton bags of industry waste that were piled up high at the end of the tunnel. ...This was quite possibly one of the most disgusting things I've done in my entire life. We were clambering over these massive bags of waste with the goal of reaching the other end of the tunnel, there were creatures scuttling out of the bags and the further we went, the worse it smelled. The bags were coated in spider webs, thick creepy spiderwebs and everything was coated in dew, because down this end of the tunnel it was both warm and humid to an extreme, we could actually see the humidity, it was like a fog. ...

... Then there was sludge. Smelly, disgusting, sludge. Probably about knee height, but we weren't going to test it. We stood in disbelief unable to cross the revolting cesspit that lay before us. We were so close, we could see the light at the end of the tunnel, but it was severely overshadowed by the horrendous environmental impact of what we could see and smell. Standing in silence, we could hear a waterway, my heart broke.

The description and photos of the amount of waste found, how the waste was stored (ie not contained in any way), and the level of water inflow and sludge in the tunnel (noting the tunnel was discontinued as a railway tunnel due to water inflows), defies belief. The Society can only concur with the writer – the mushroom compost and other waste in the tunnel represents a major environmental risk, a risk which until the Society uncovered the website referenced above, was largely unknown to the Society and the community.

Small selection of photos taken inside the tunnel in 2016 from
<http://photomofo.myphotojournal.com/2016/apr/14/shroom-farm/>
